Report on the investigation of
the collision between
mv Ash and mv Dutch Aquamarine
in the SW lane of the Dover Strait TSS
with the loss of one life
9 October 2001

Marine Accident Investigation Branch
First Floor
Carlton House
Carlton Place
Southampton
United Kingdom
SO15 2DZ

**Report No 7/2003
March 2003**

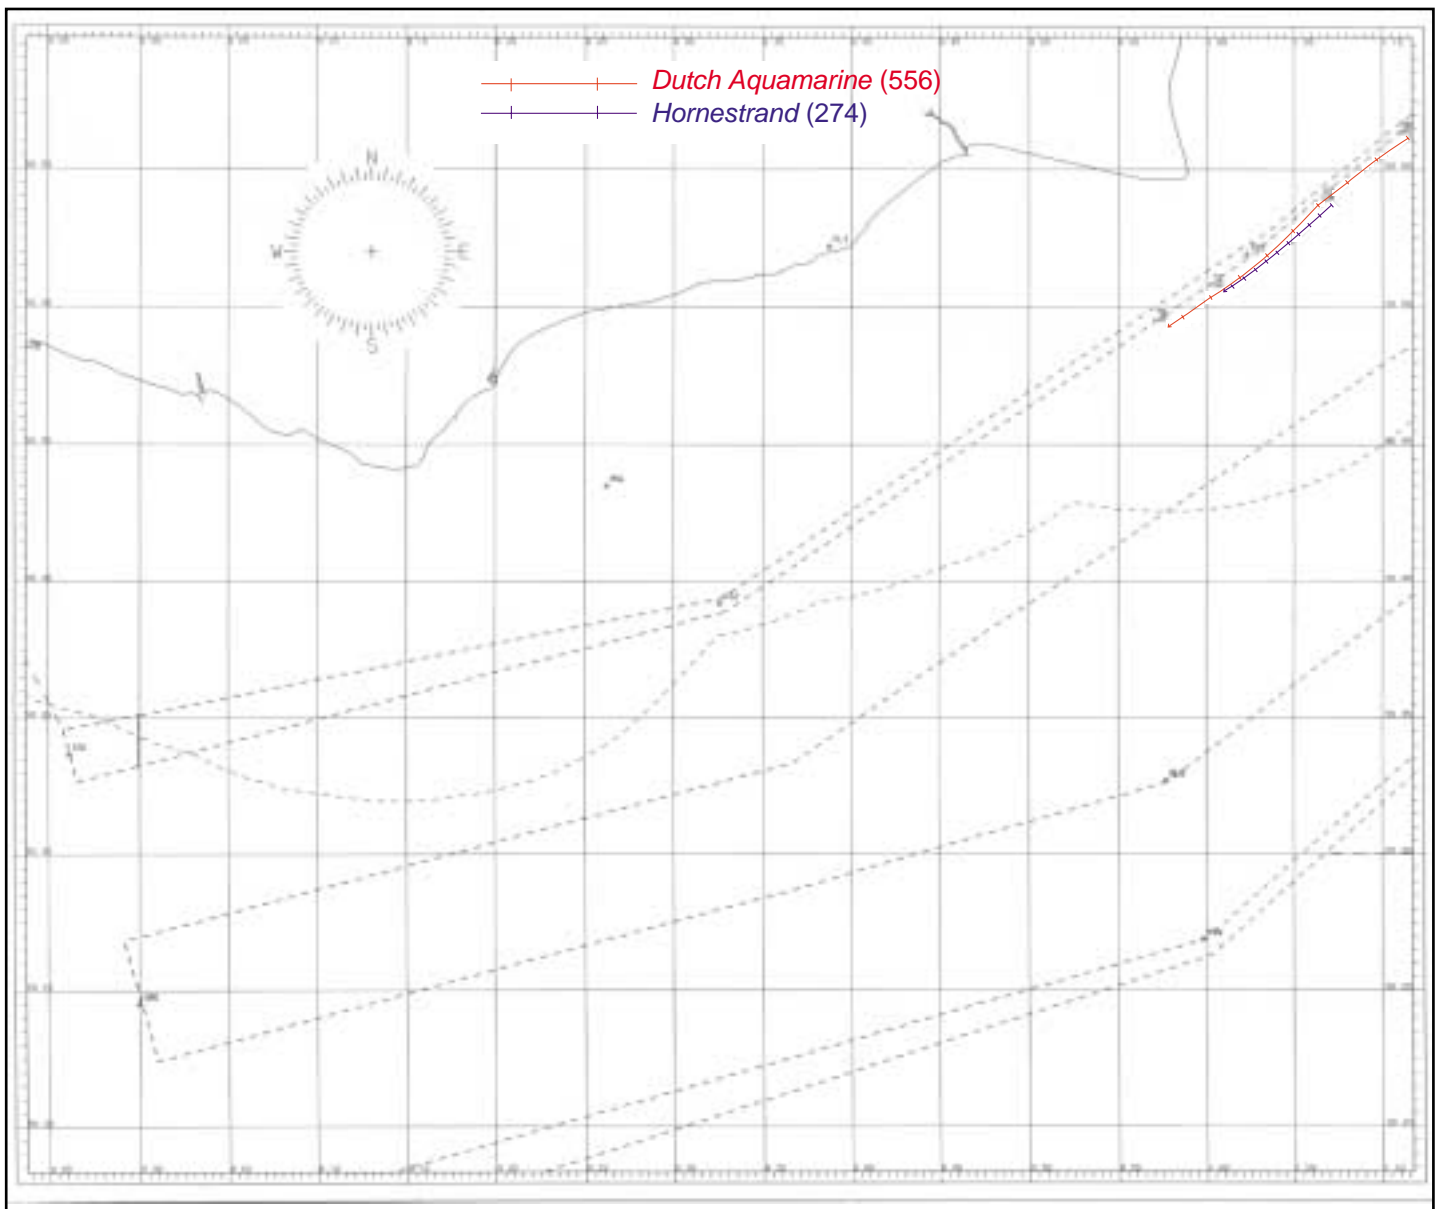
Plan 2

At about 1508, as soon as she was clear of the vessels that had been overtaken, *Dutch Aquamarine* returned to her planned track. At 1512, she overtook mv *Hornstrand* (5 knots) at a distance of about 0.15 mile on her port side (see Plan 2). She was about 0.5 mile south of CS3 buoy at this time.

Extract from CNIS plot showing the tracks of *Dutch Aquamarine* and mv *Hornstrand*

Where a track control system is used, it is, possibly, even more likely that the navigator will want to return the vessel to the planned track quickly after any deviation. It should be noted in this context that Vopak's fleet orders to navigating officers instruct them to ensure that *".....the GPS gives the autopilot a course to return the ship as quickly as possible to the track to be sailed between the set waypoints."* A graphic example of this occurred when *Dutch Aquamarine* reverted to her original track after passing *Lapad* at about 1505. *Dutch Aquamarine* reverted to her track despite the fact that this meant that she passed *Hornstrand* at 1512 at a distance of only about 0.15 mile (**see Plan 2**).

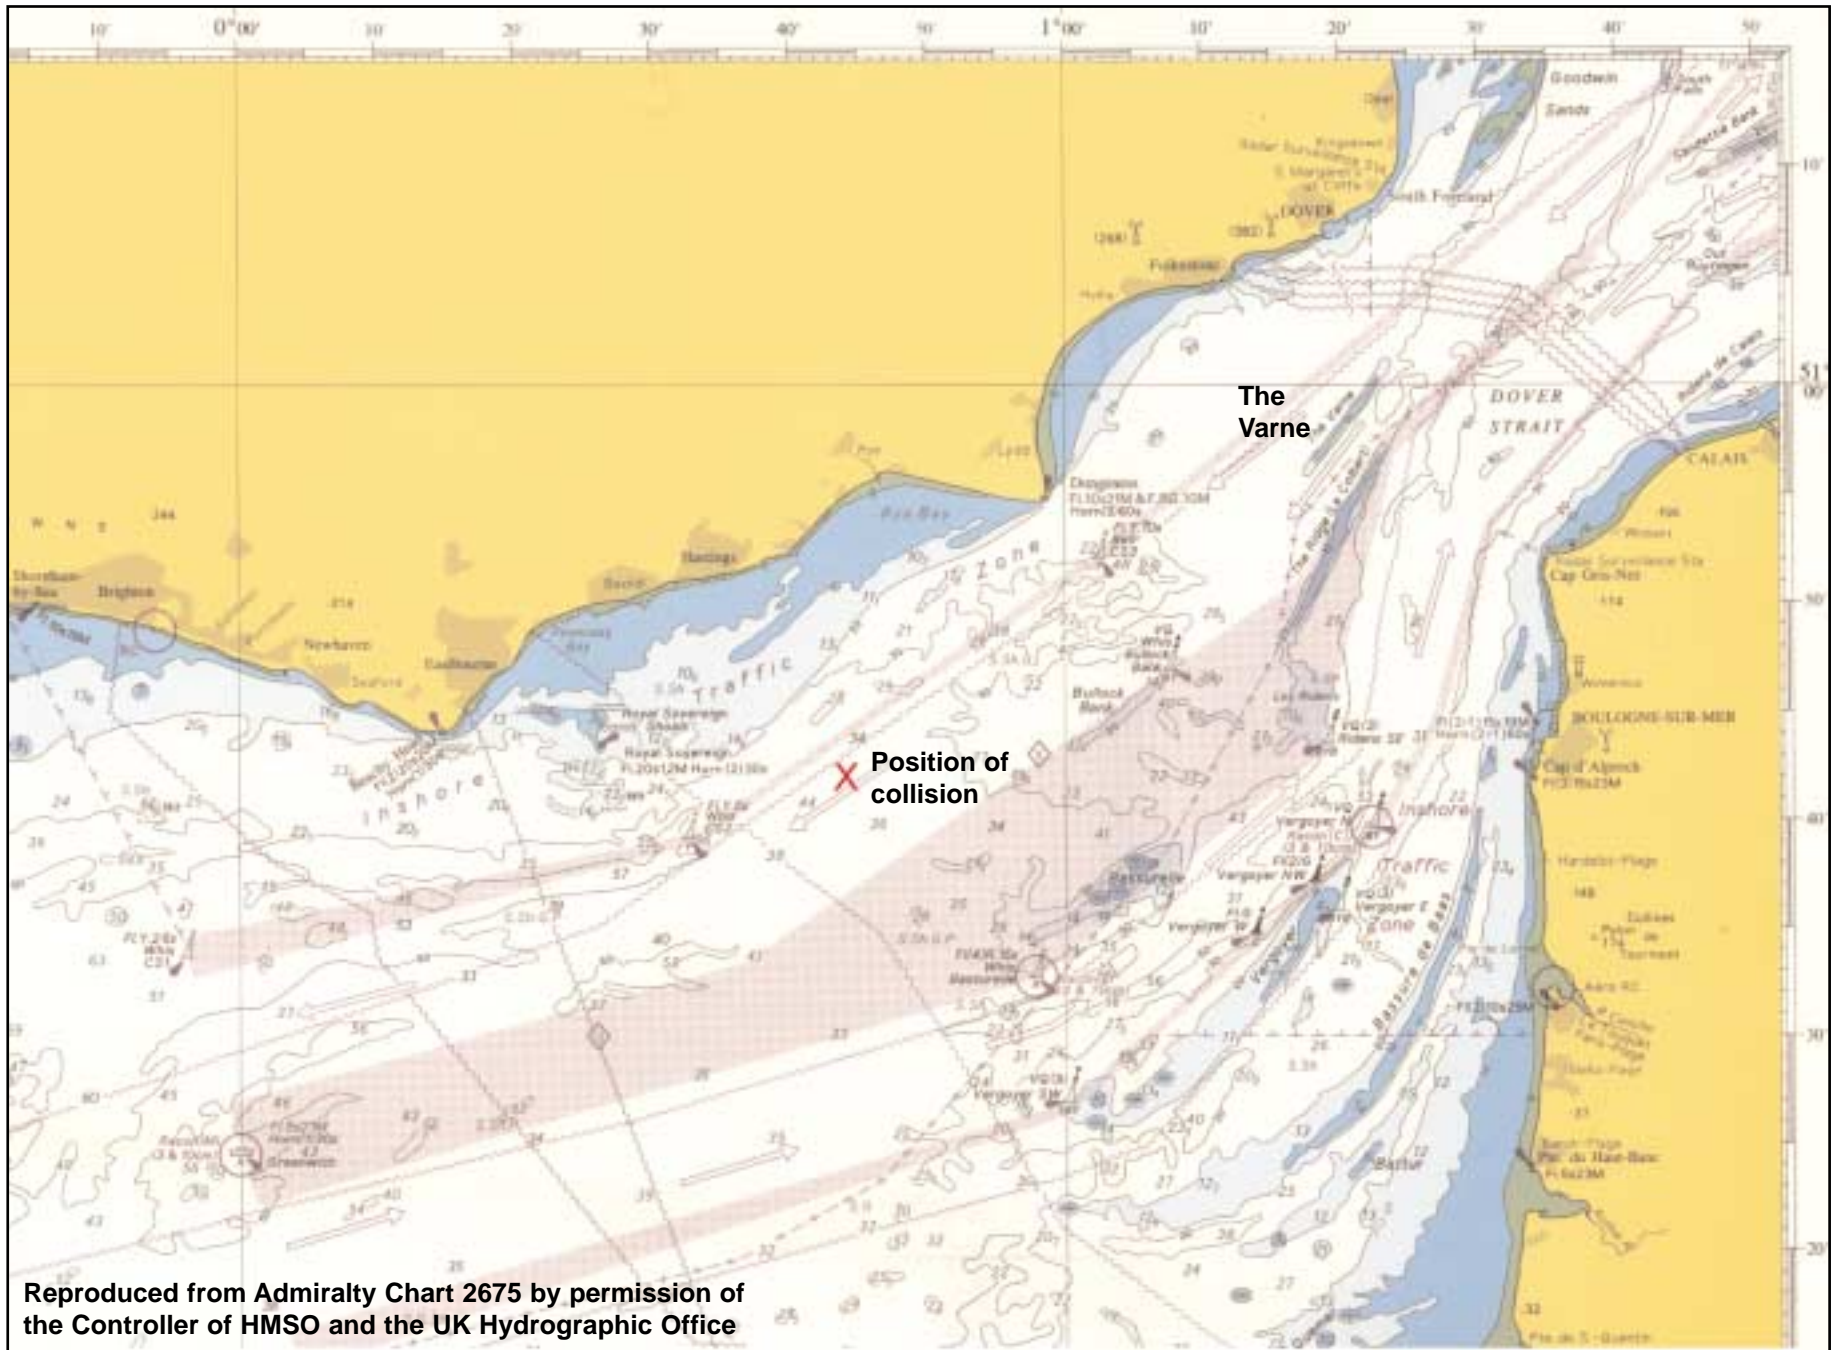
Dutch Aquamarine's second officer did not notice *Ash* in the period immediately prior to the collision until she was very close and right ahead. At about the time that *Dutch Aquamarine* struck the starboard quarter of *Ash*, the second officer put *Dutch Aquamarine's* helm hard to starboard and the engines full astern. The collision occurred at 1620 and after the initial impact *Dutch Aquamarine* scraped up *Ash's* starboard side (**see chart extract**).

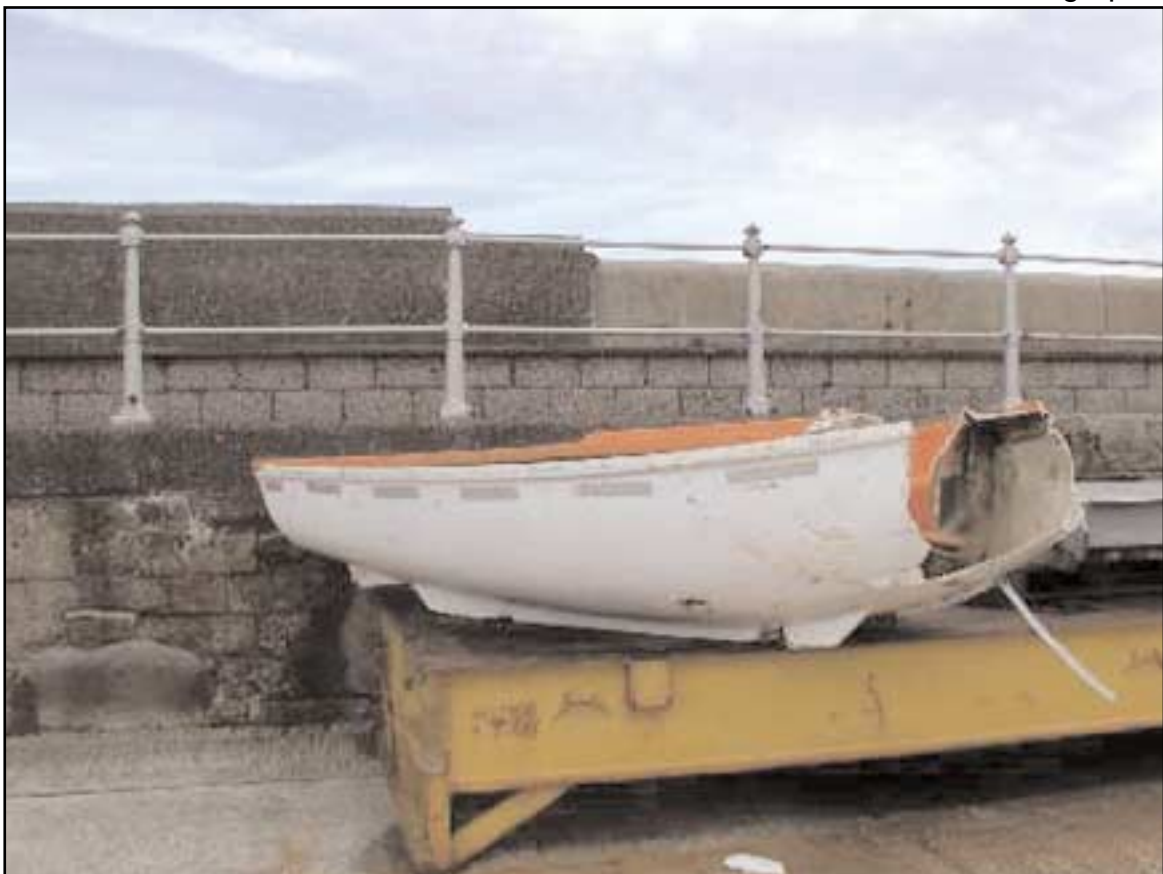
Photograph 3

The damage on the starboard quarter included signs of an impact right aft where the bulwark in the mooring area was found to be bent in and over the three adjacent fairleads. This impact apparently damaged the lifeboat davit arm on the bridge deck which was bent inboard to an angle of 30°. Part of the lifeboat was recovered from the water after the accident (**see Photograph 3**). The boat had been stowed bow to starboard across the after end of the bridge deck in way of this impact area. It can be seen from the photograph that the bow of the lifeboat is missing. A few metres further forward, the railings on the starboard side of the bridge deck were discovered to have been bent inboard, and there were signs of another impact.

Part of the lifeboat recovered after the accident

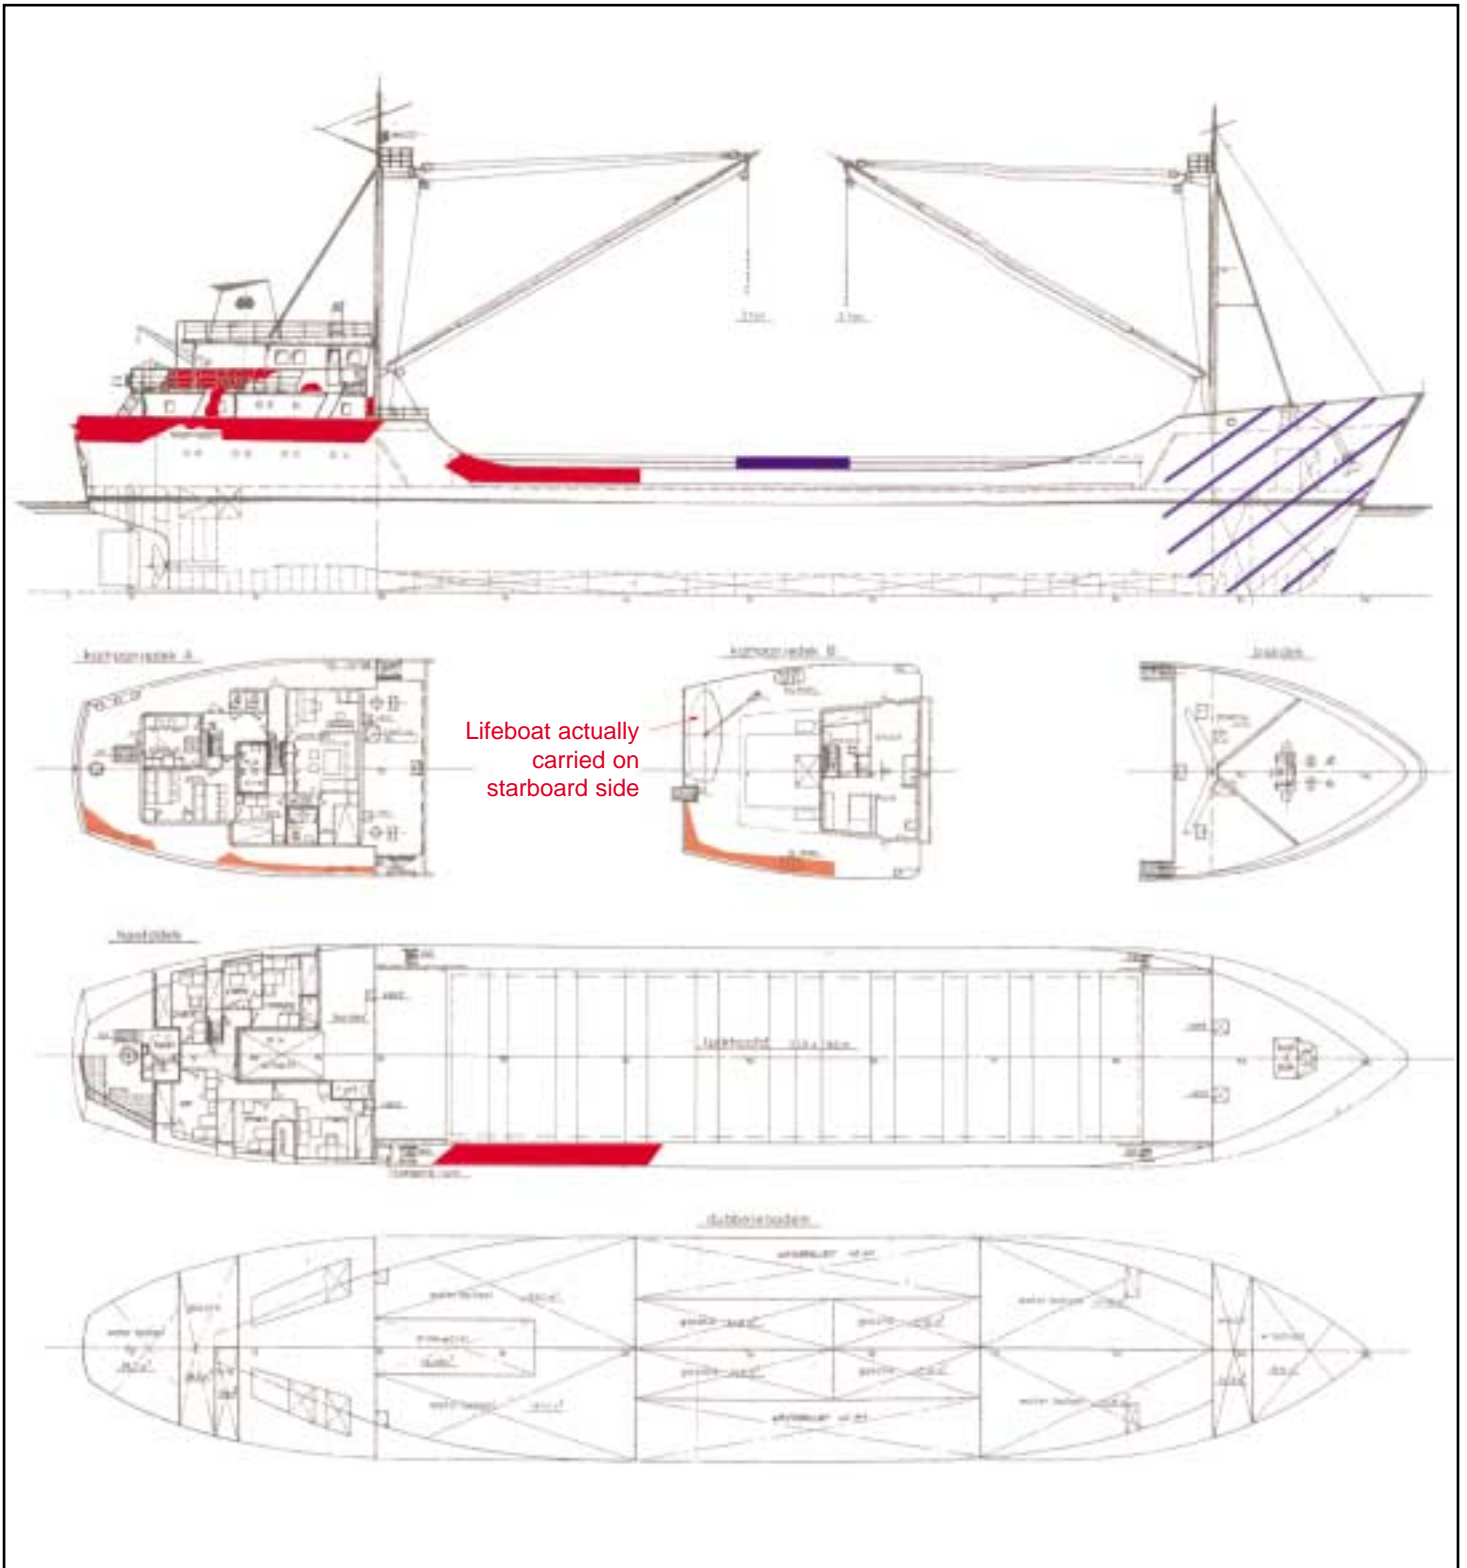
Ash was found to have been damaged in four main areas: the starboard quarter, including the starboard side of the bridge deck and mooring deck; just forward of the superstructure in way of the main cargo hold; an area of buckling at about mid-length; and severe damage in the bow area (**see Figure 1 overleaf**).

A major area of impact was seen just forward of the superstructure in way of the cargo hold.

Areas found to have been damaged

Ash's length was about 23m greater than the water depth. It is considered likely that the bow sank to the seabed, leaving the stern at the surface, temporarily supported by residual buoyancy in the engine room. The area of buckling found at about mid-length is thought likely to have been caused when the bow hit the seabed. The divers who visited the wreck reported extensive damage to the bow area which is also thought to have occurred at this time.

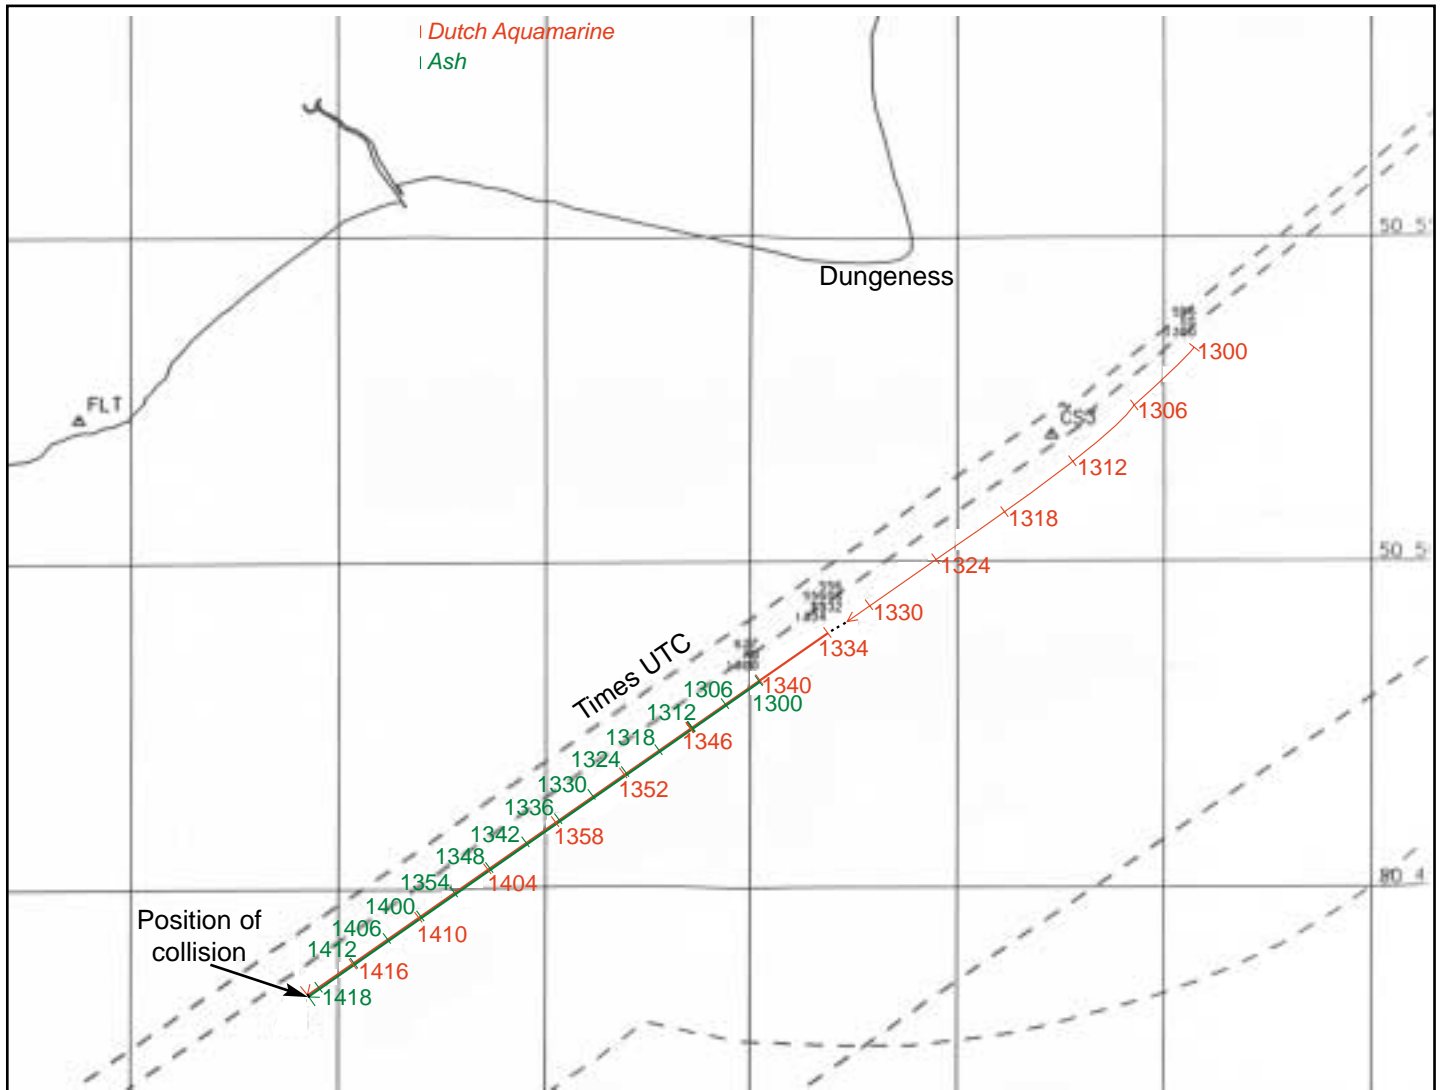
Plan 3

Extract from CNIS plot showing the tracks of *Dutch Aquamarine* coincident with that of *Ash*. Marks at 6 minute intervals.

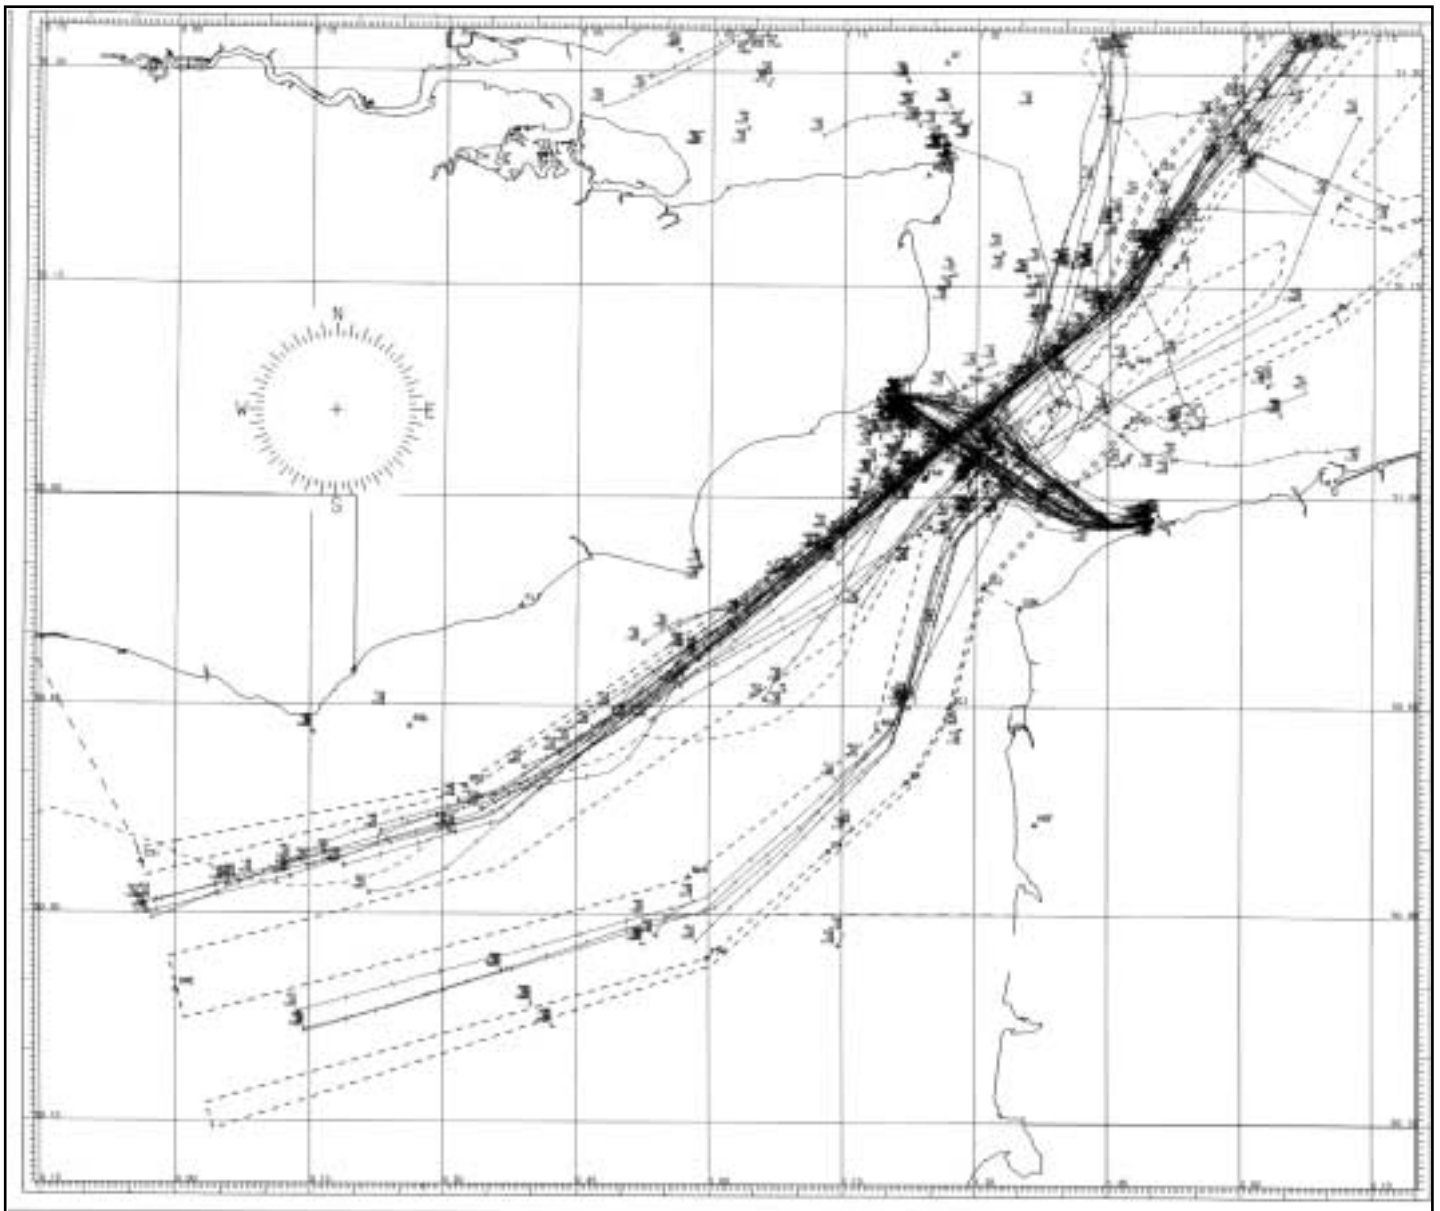
Plan 4

Extract from CNIS plot showing tracks of all the vessels in the Varne Bank area between 1200 and 1800 on the day of the accident

4. The large majority of vessels transiting the Dover Strait in the south-west traffic lane choose tracks which run parallel and close to the northern edge of the lane. This causes bunching of traffic in this area. [2.3.1]
